FINAL DESIGN REPORT / ENVIRONMENTAL IMPACT STATEMENT

Appendix L – Bridge Information

Highway Project
P.I.N. 1721.51
BINs: 1033141 / 1033142
Interstate 87 (I-87) Exit 4 Access
Improvements
Albany County

BIN 1033141

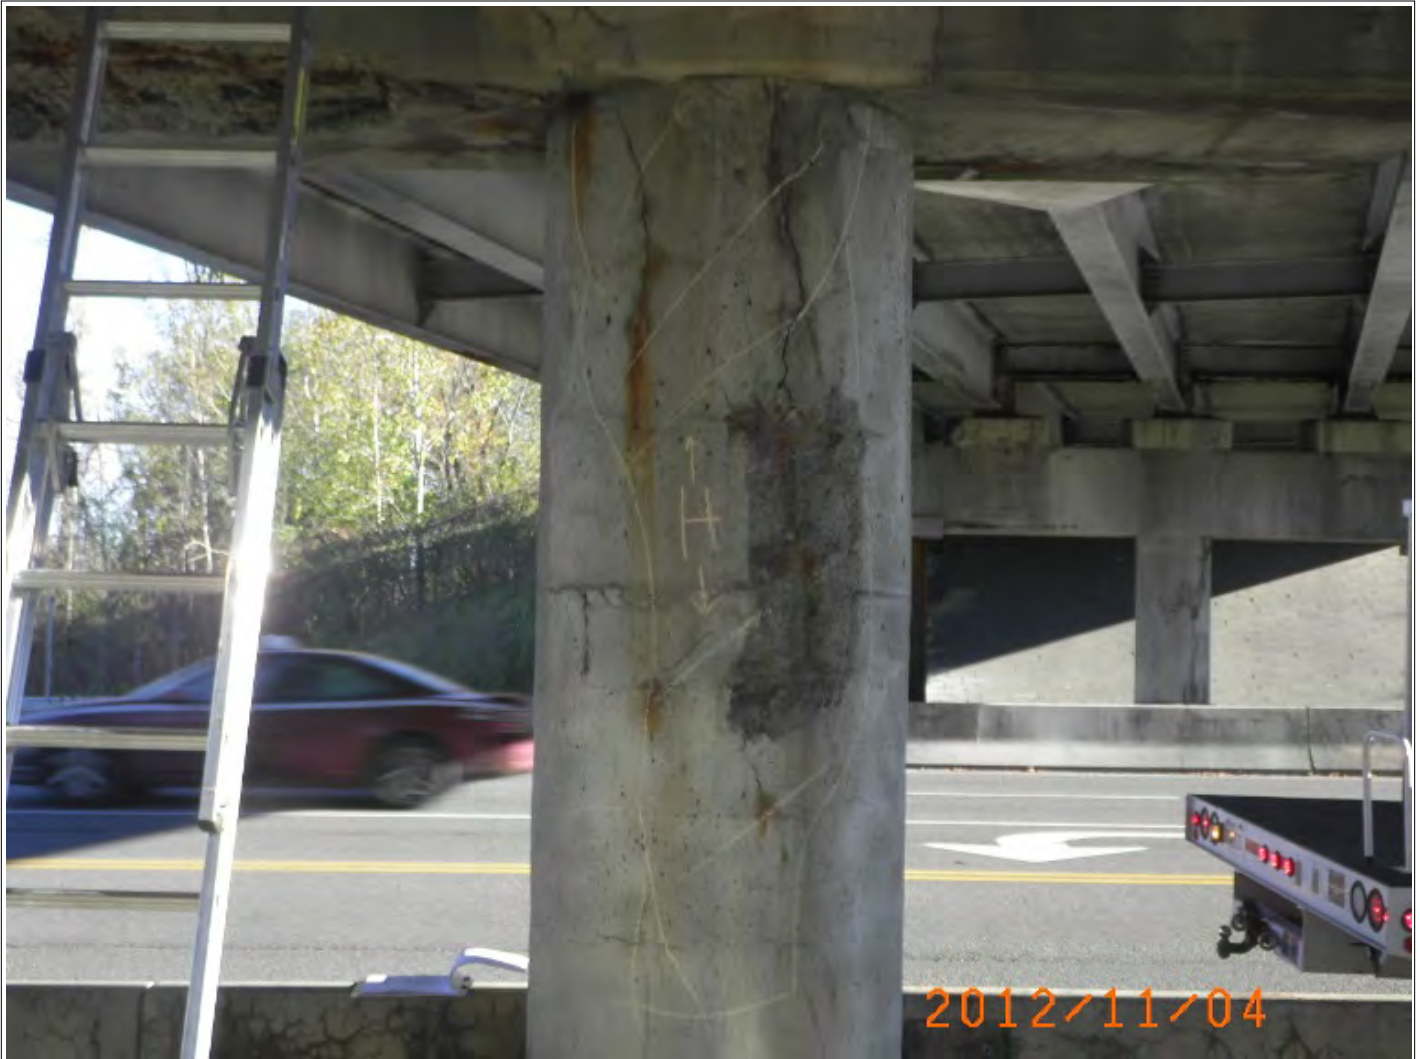
12-2816.JPG - Attached to Yellow Flag 1P120029

Column 2 Begin Face

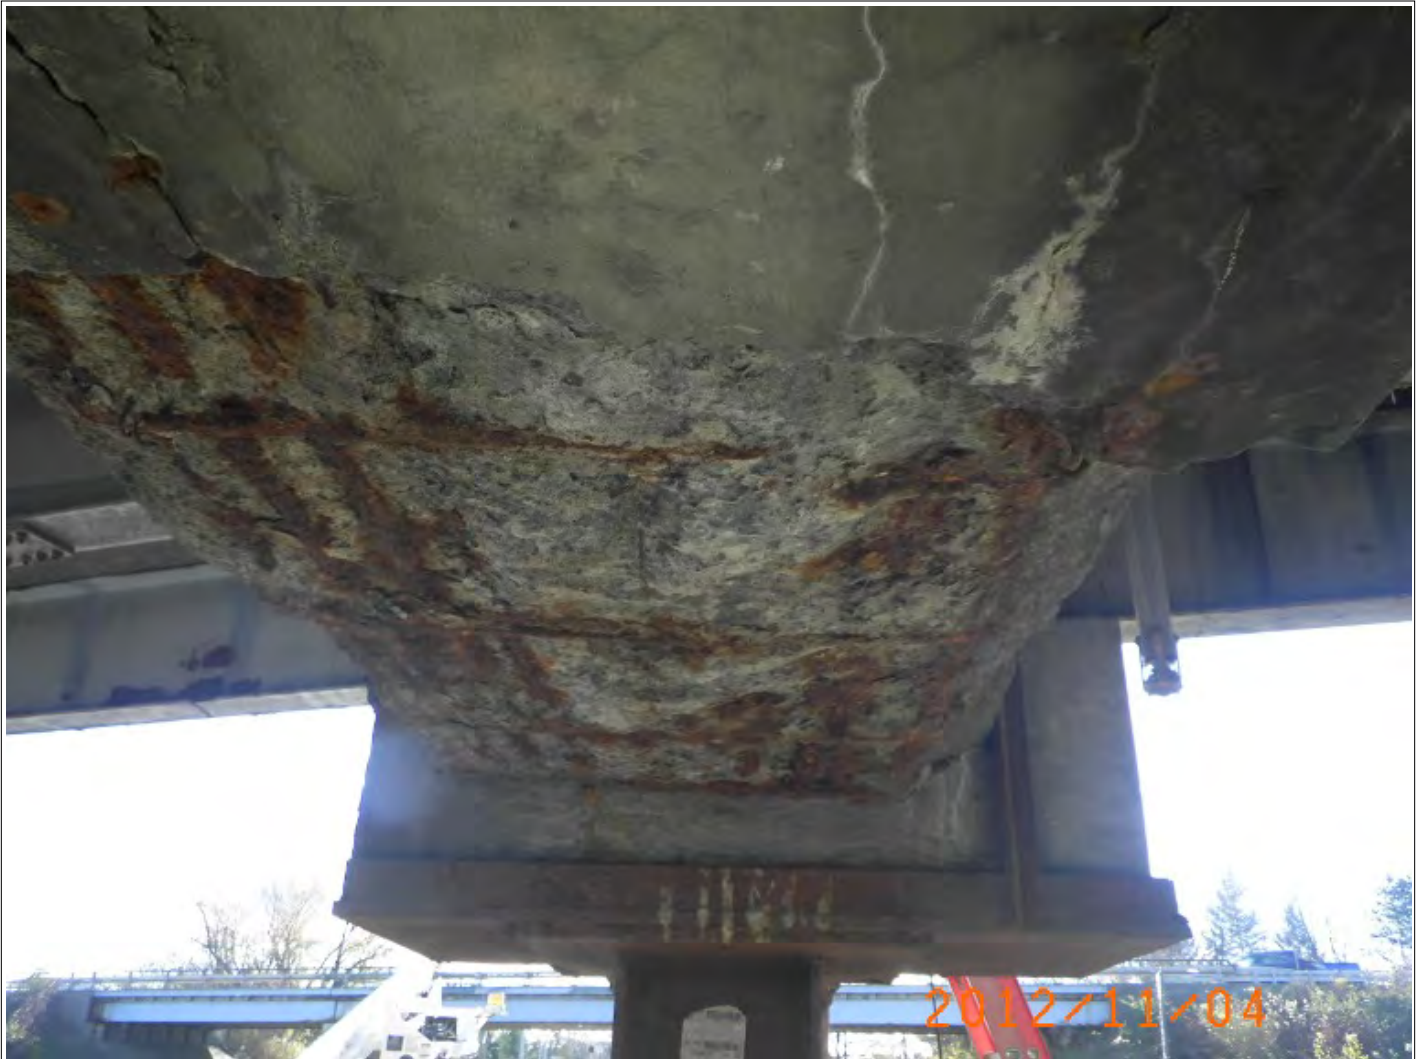
12-2834.JPG - Attached to Yellow Flag 1P120029

Cap Bm Bay 1 to right of steel col

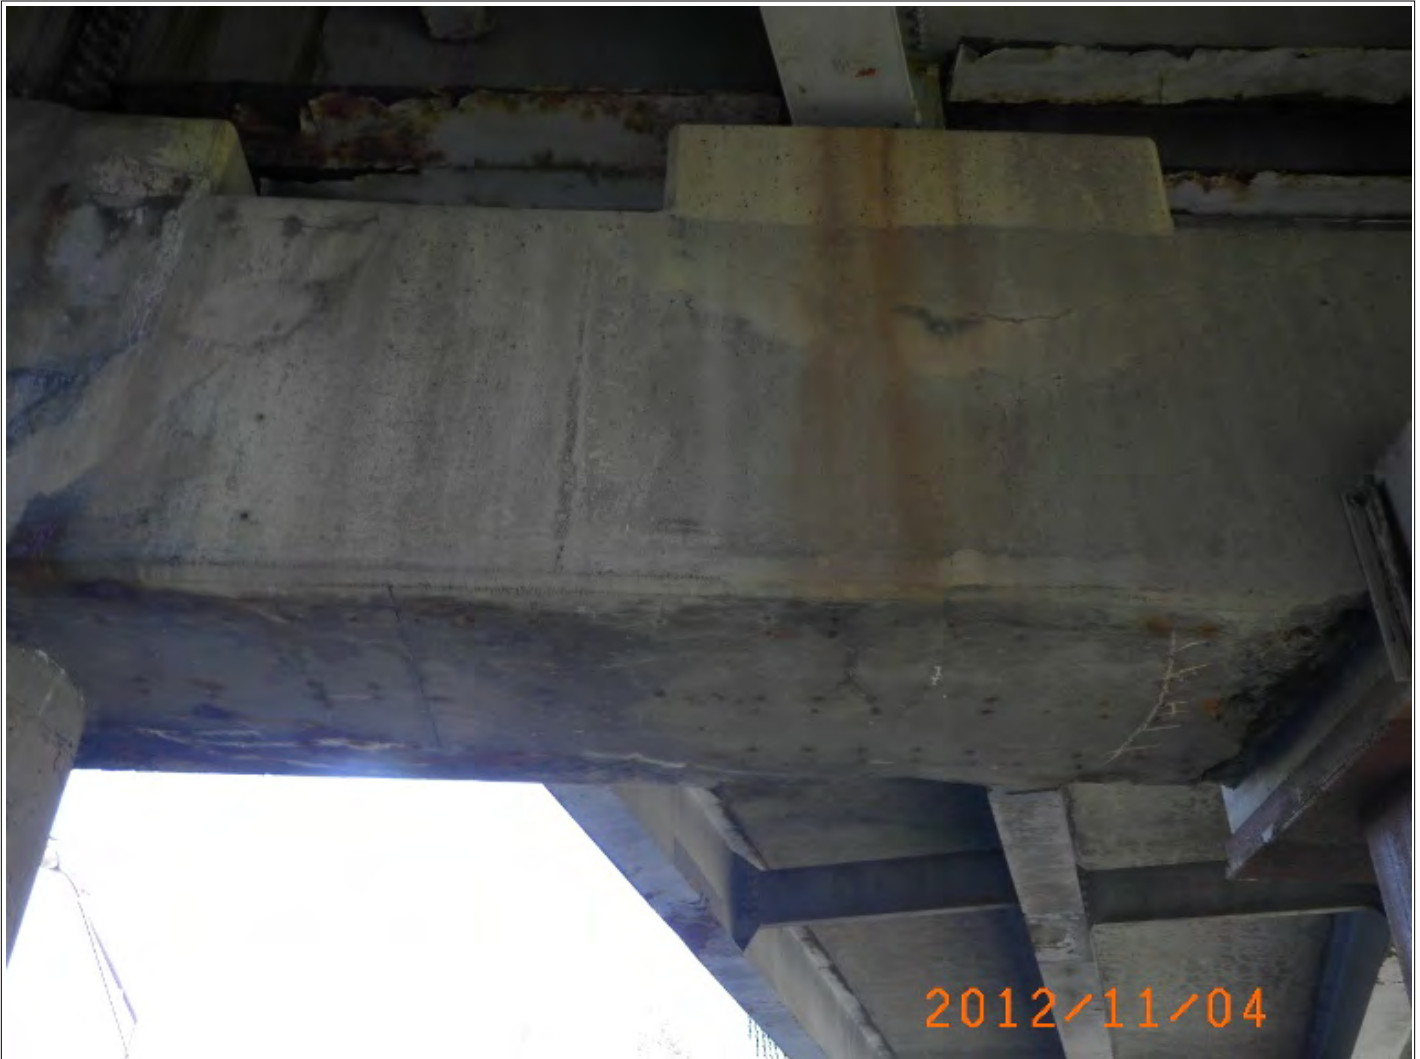
12-2856.JPG - Attached to Yellow Flag 1P120029

Begin face Bay 1 - left portion

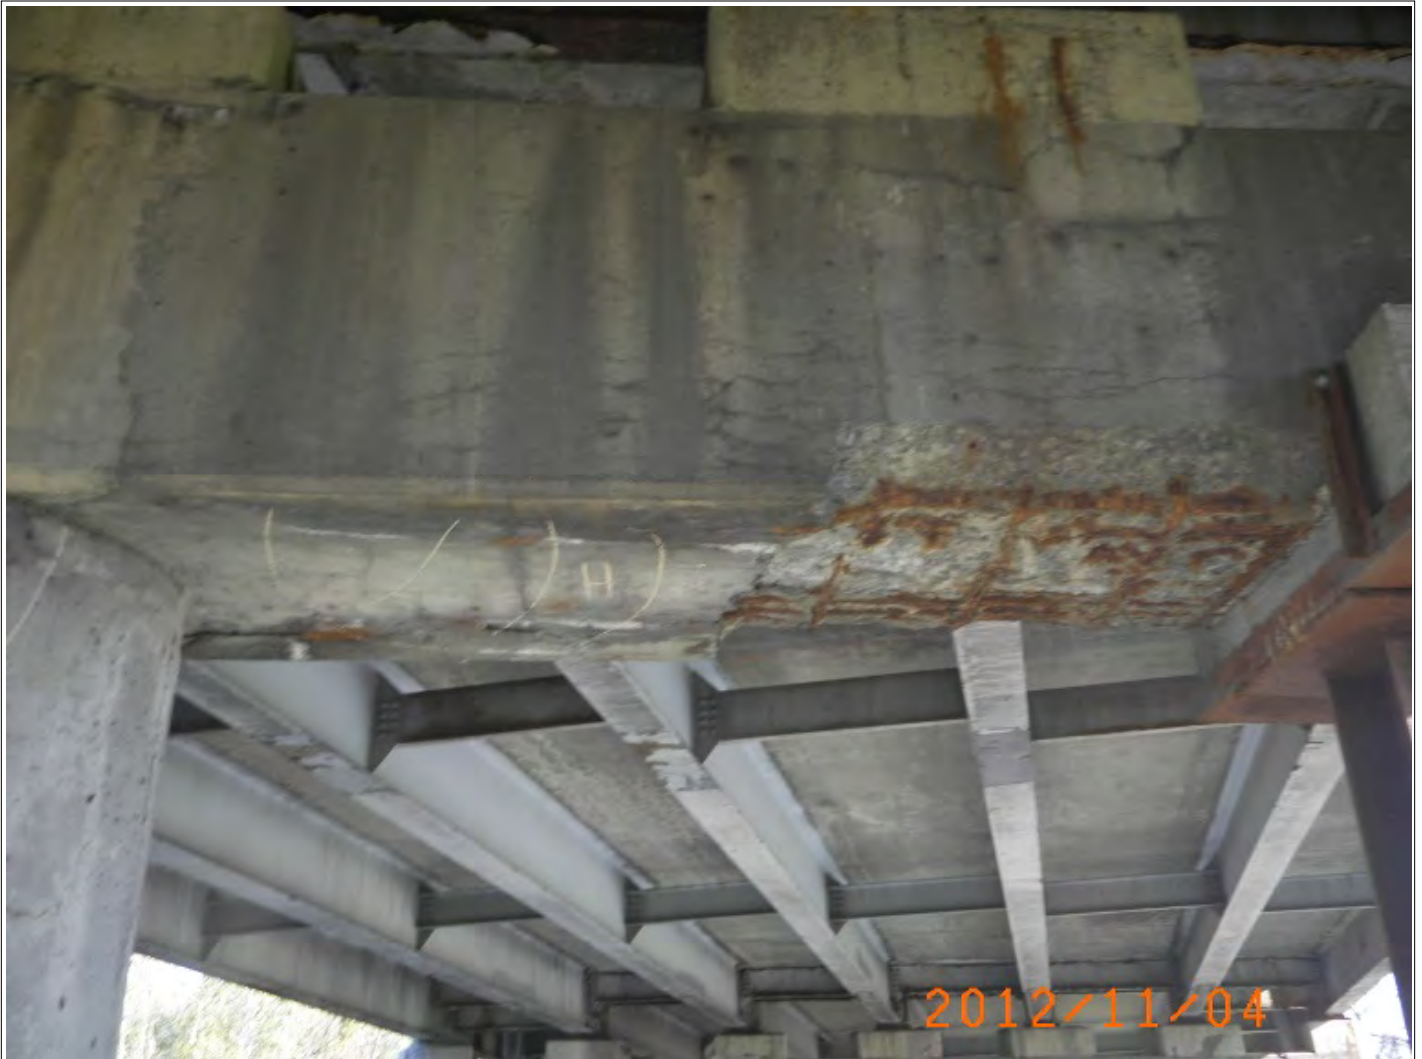
12-2857.JPG - Attached to Yellow Flag 1P120029

Begin face Bay 2 left portion

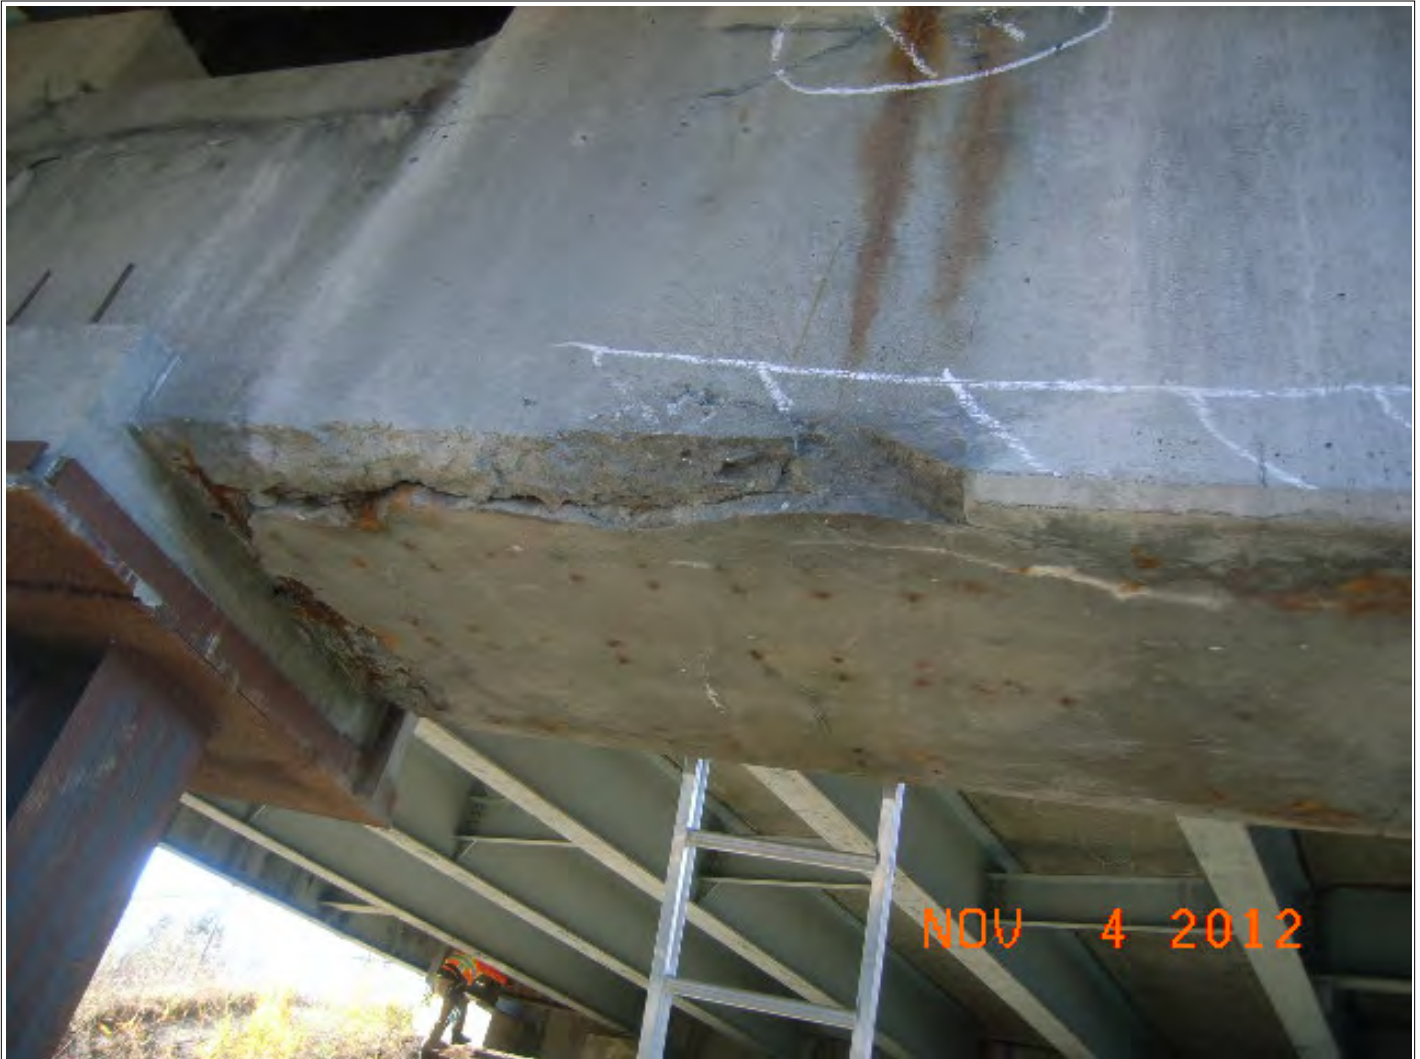
12-6834.JPG - Attached to Yellow Flag 1P120029

End face, Bay 1 Left portion

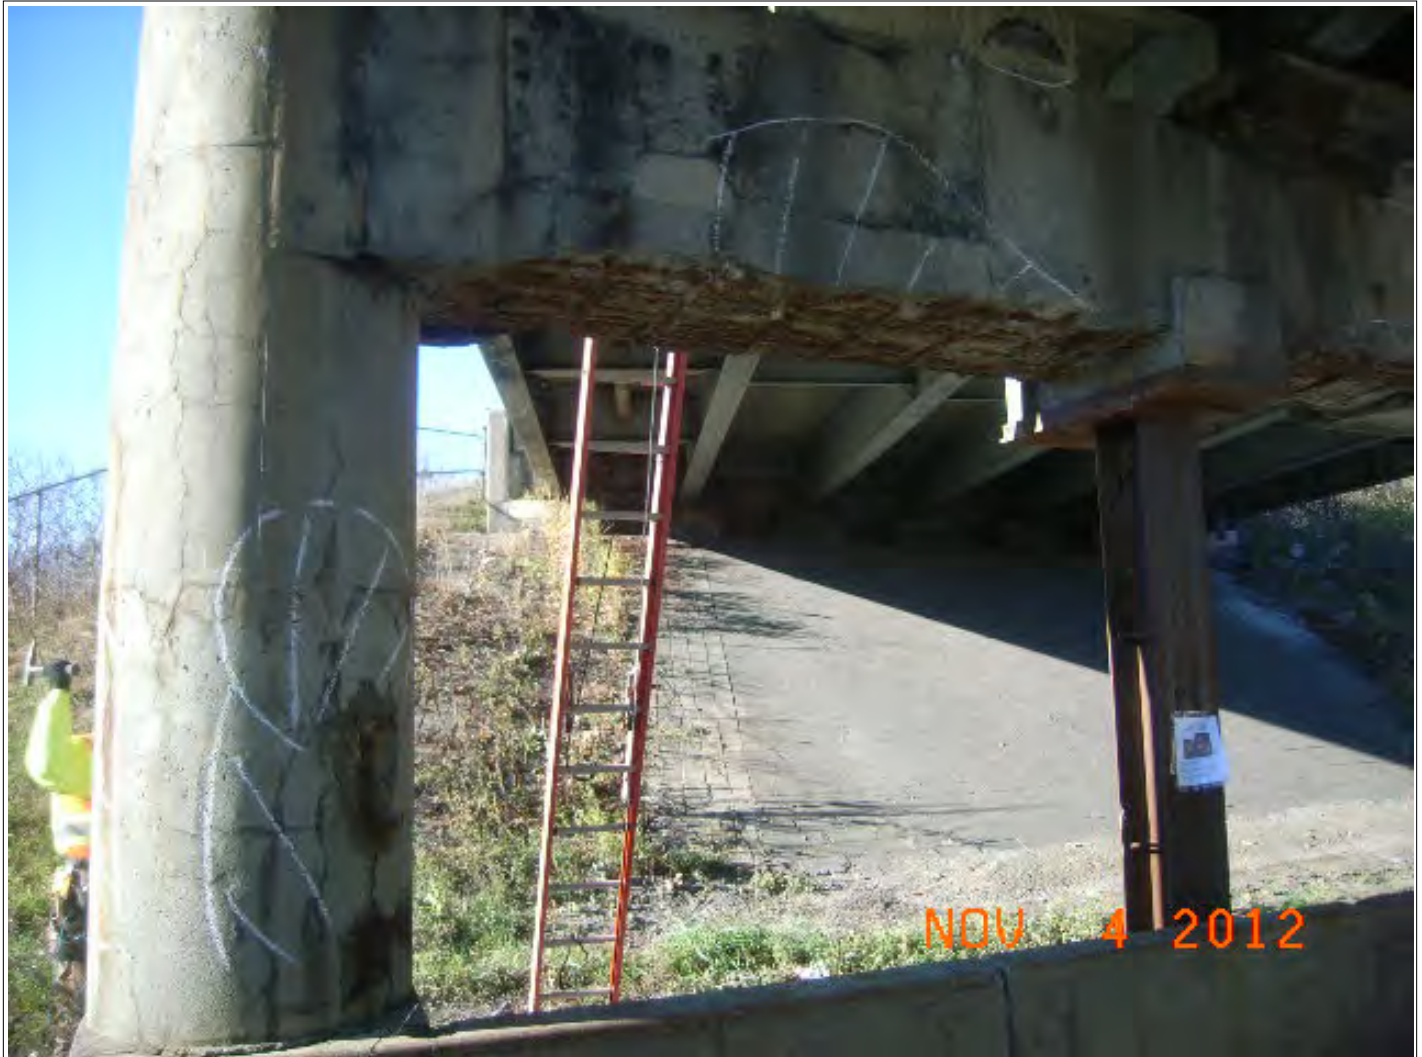
12-6888.JPG - Attached to Yellow Flag 1P120029

End face Column 3

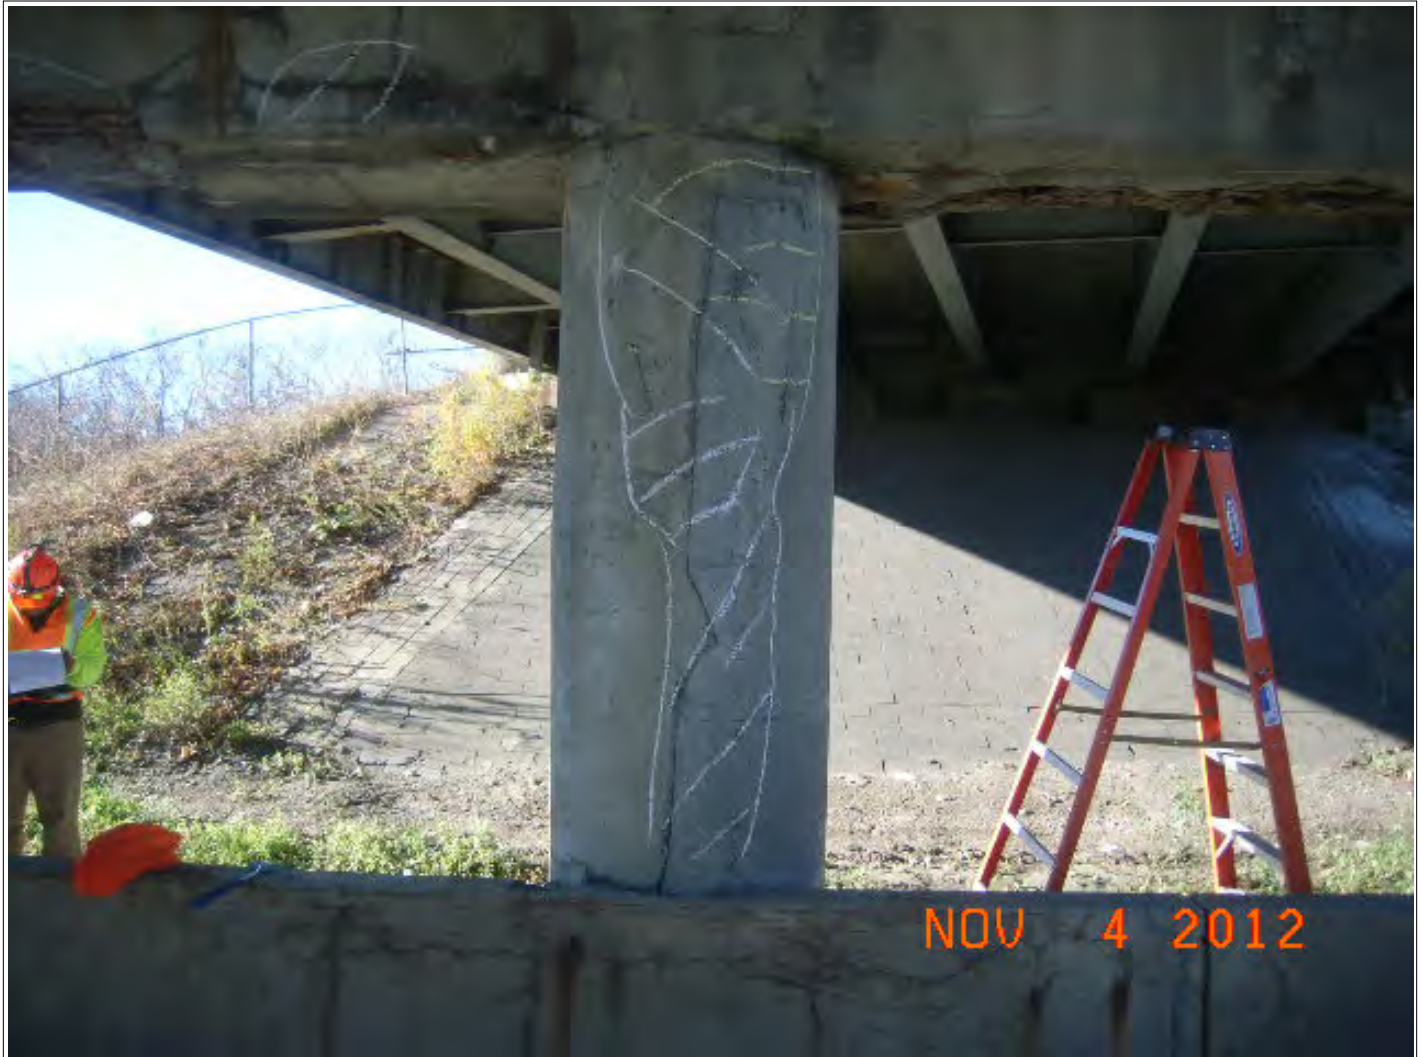
12-6889.JPG - Attached to Yellow Flag 1P120029

End face, Column 2

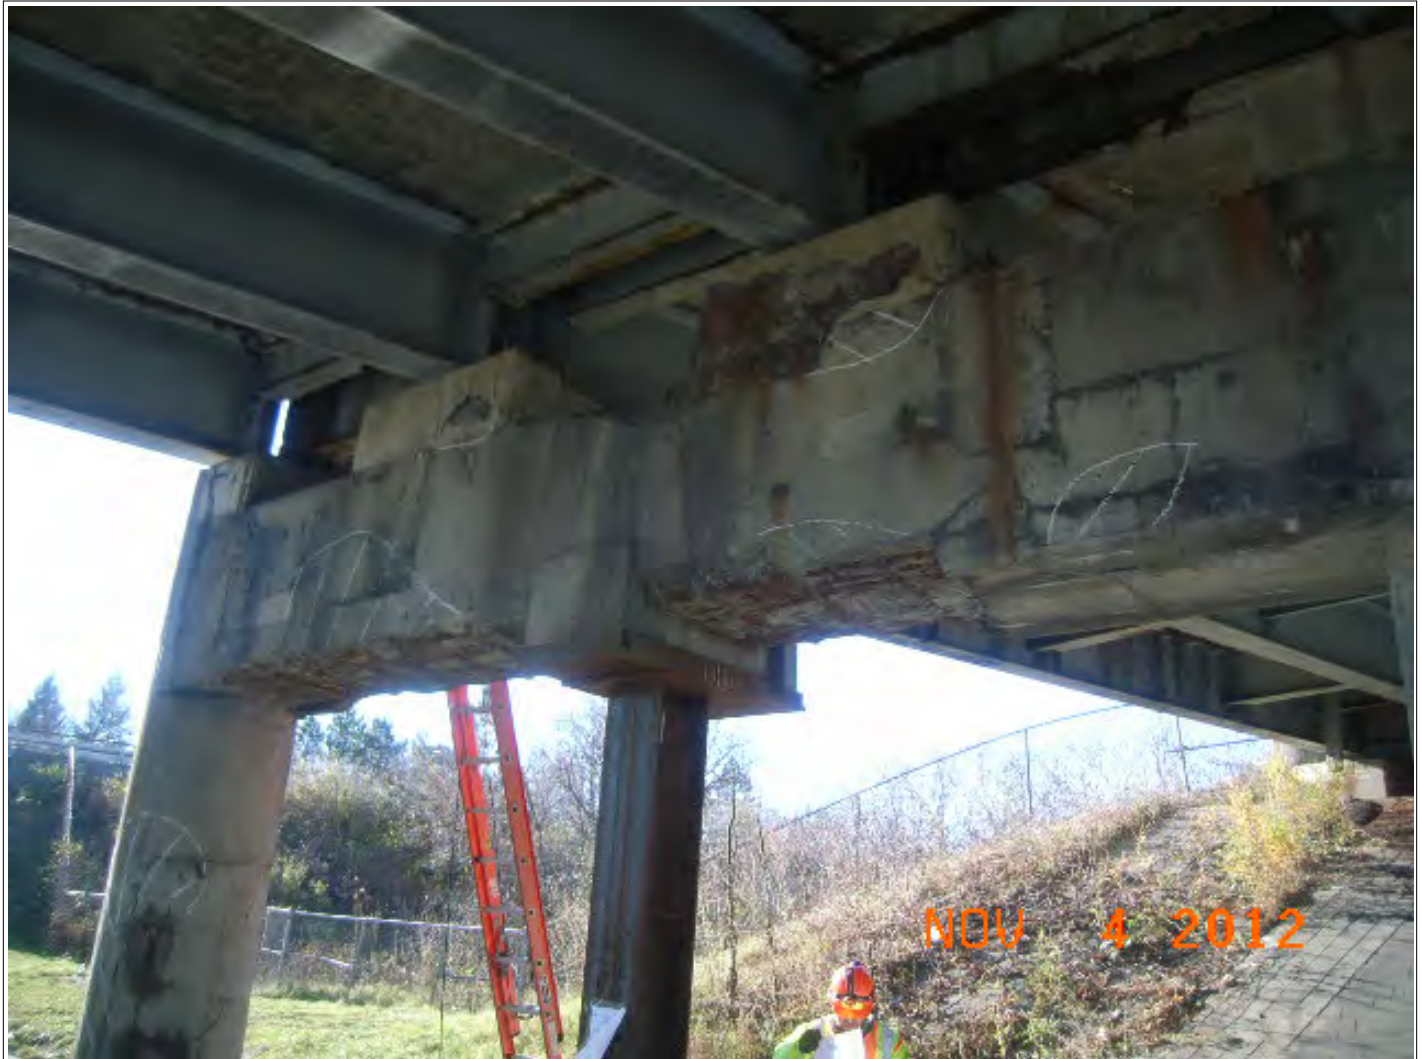
12-6890.JPG - Attached to Yellow Flag 1P120029

End face Bay 2

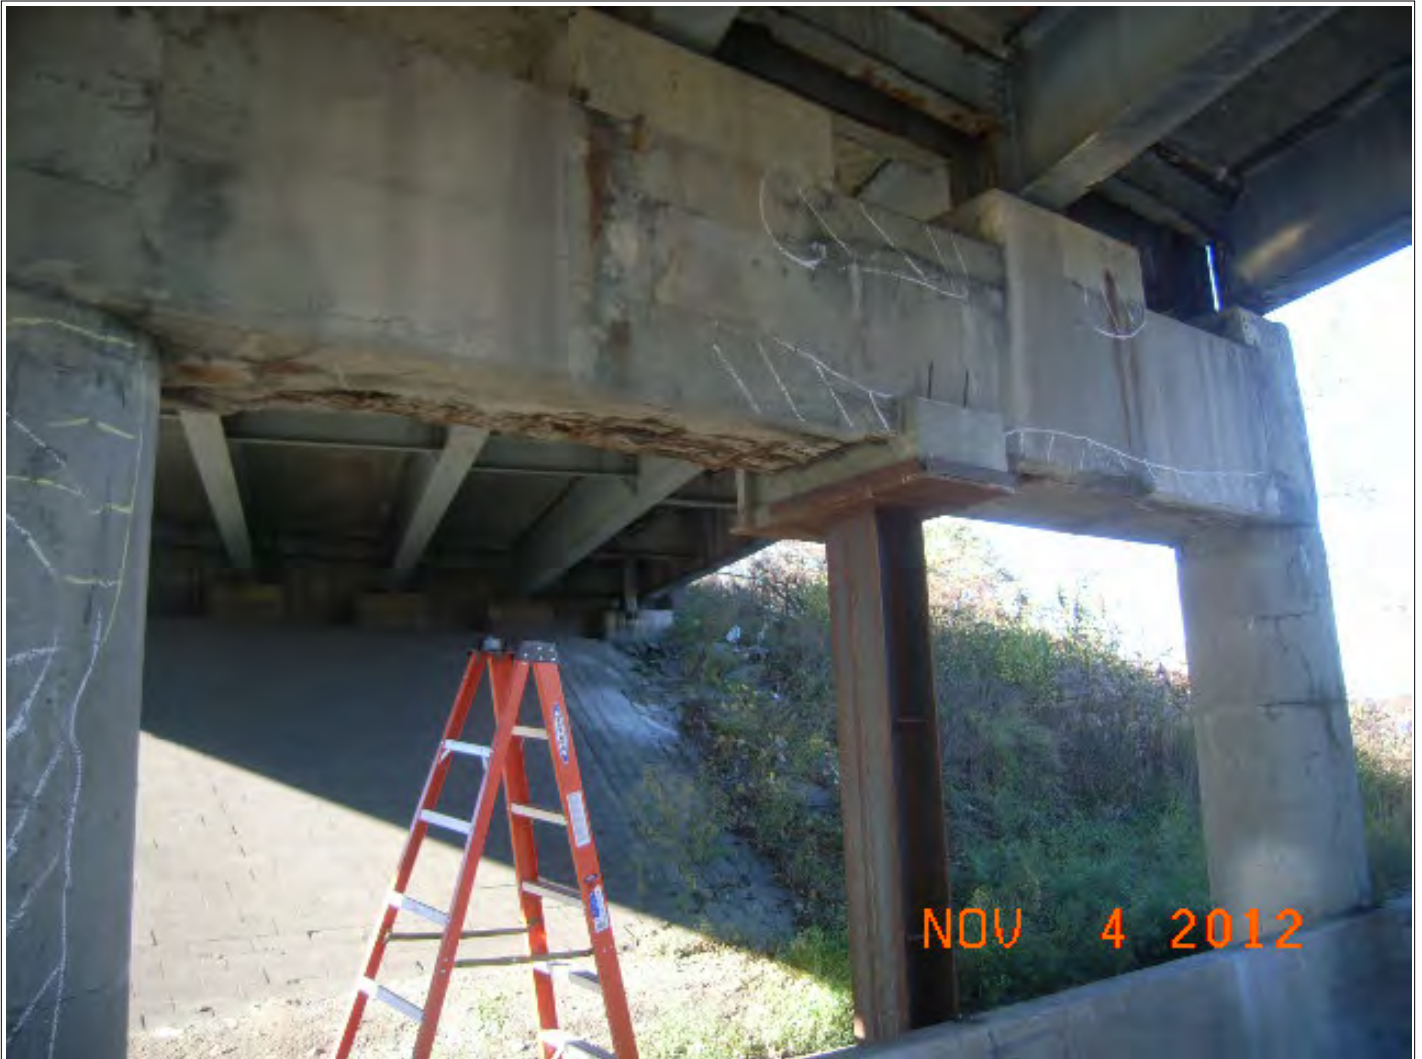
12-6891.JPG - Attached to Yellow Flag 1P120029

End face Bay 1

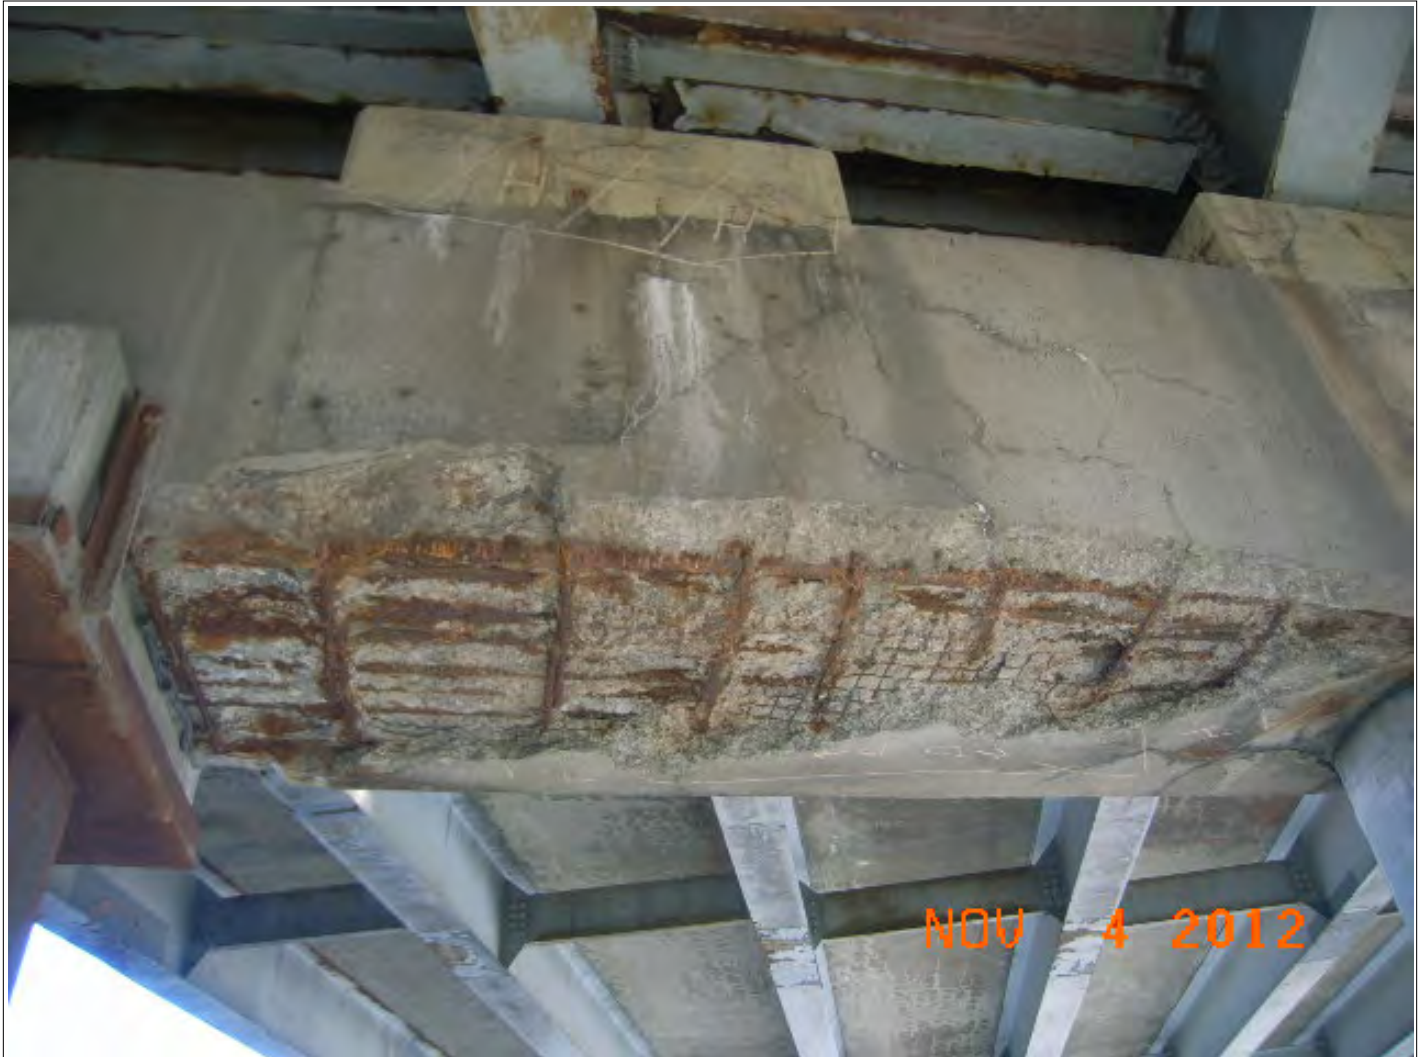
12-6923.JPG - Attached to Yellow Flag 1P120029

Begin face Bay 2 Right portion

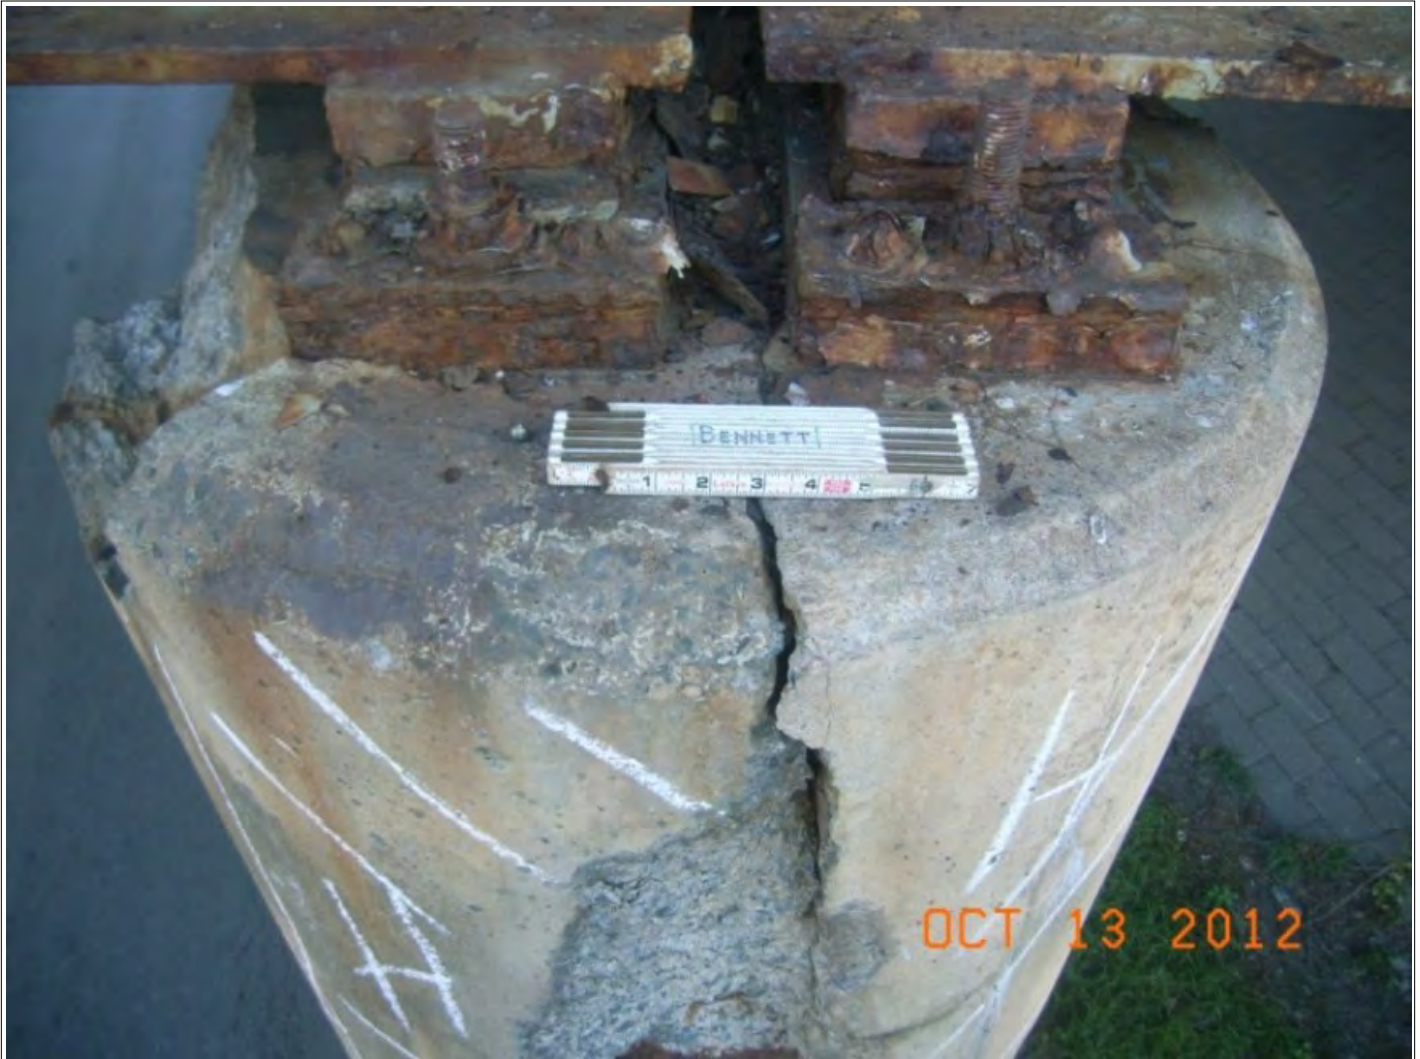
12-5619.JPG - Attached to Yellow Flag 1P120026

Pier 2, Ped 7 Right Face closeup

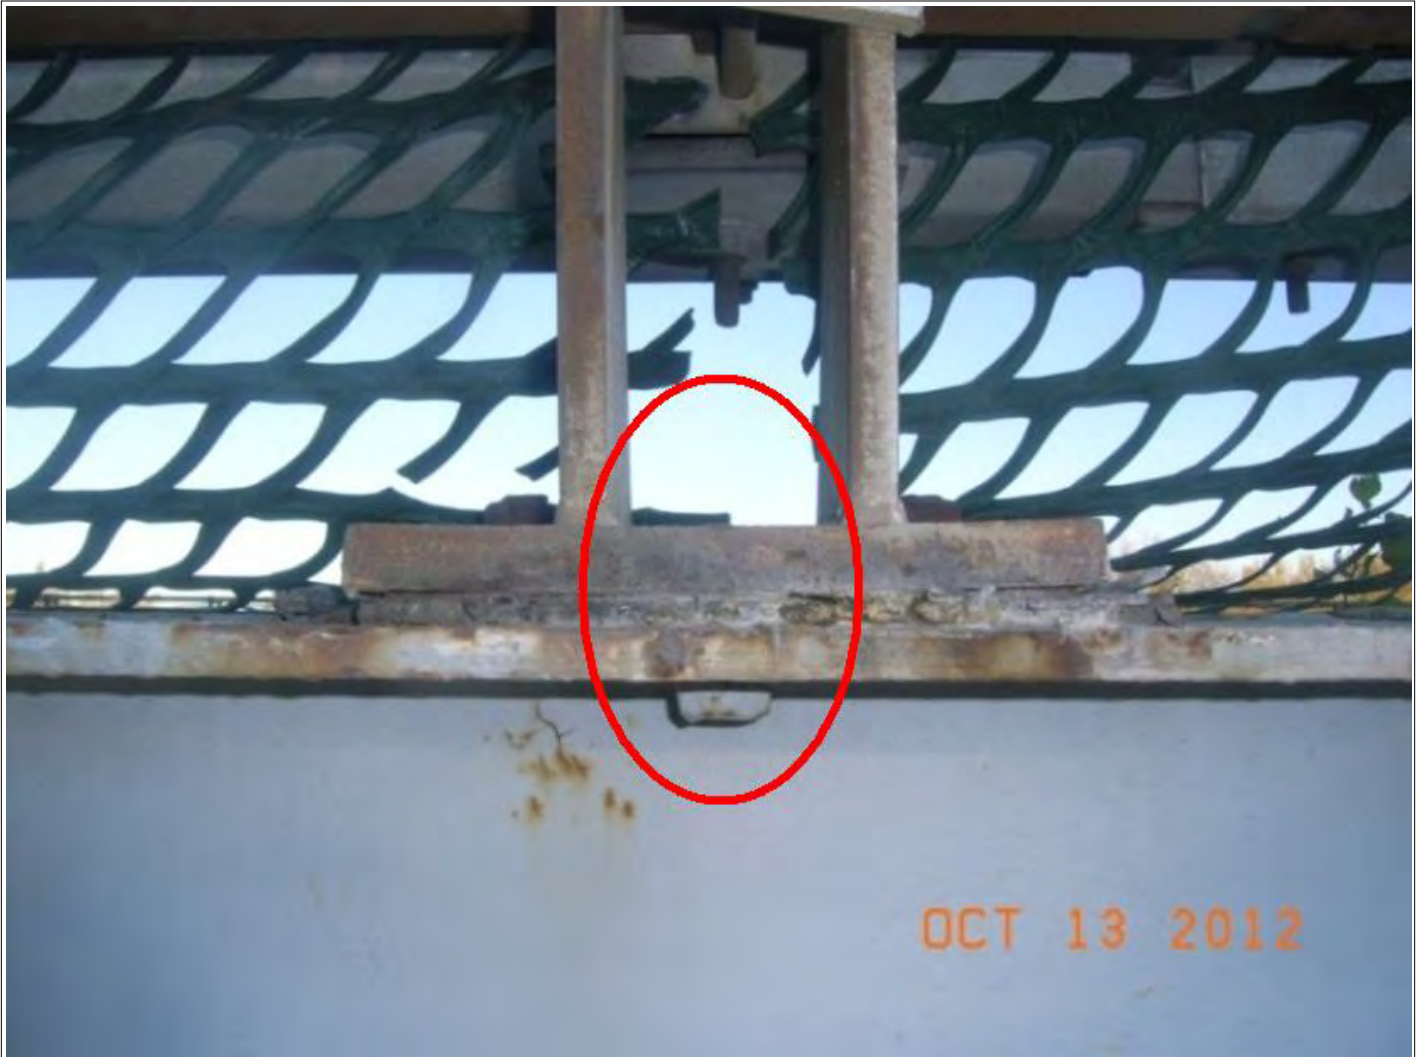
12-5632.JPG - Attached to Safety Flag 1P120027

Span 3, Right, typical view of missing bolt

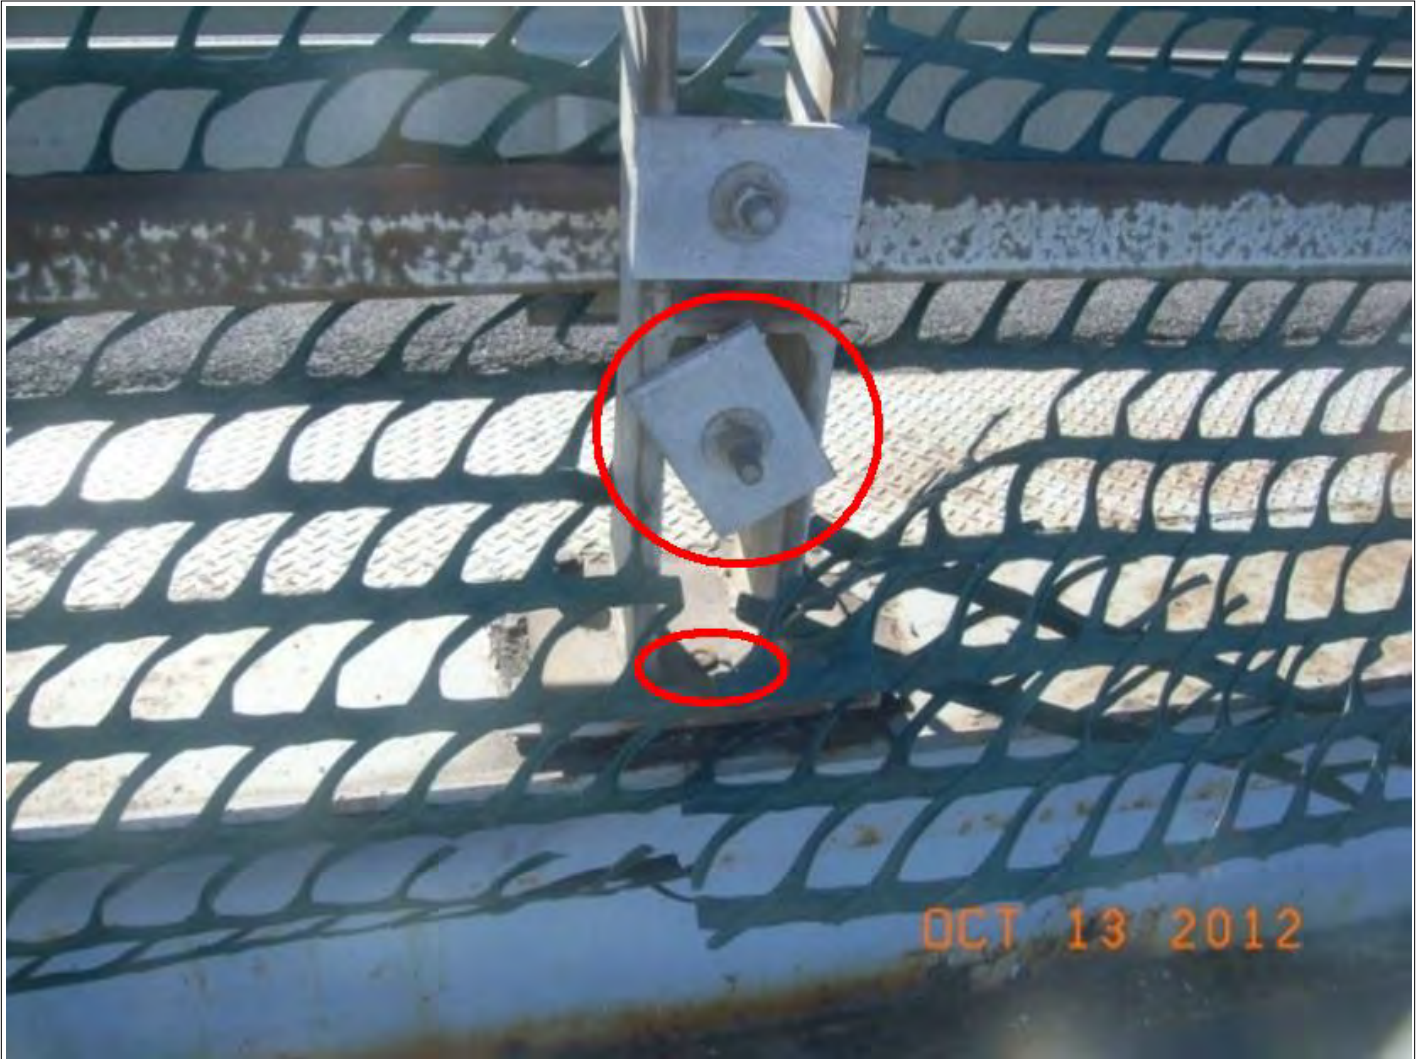
12-5667.JPG - Attached to Safety Flag 1P120027

Span 3 Right - typical view of loose rear anchor plate

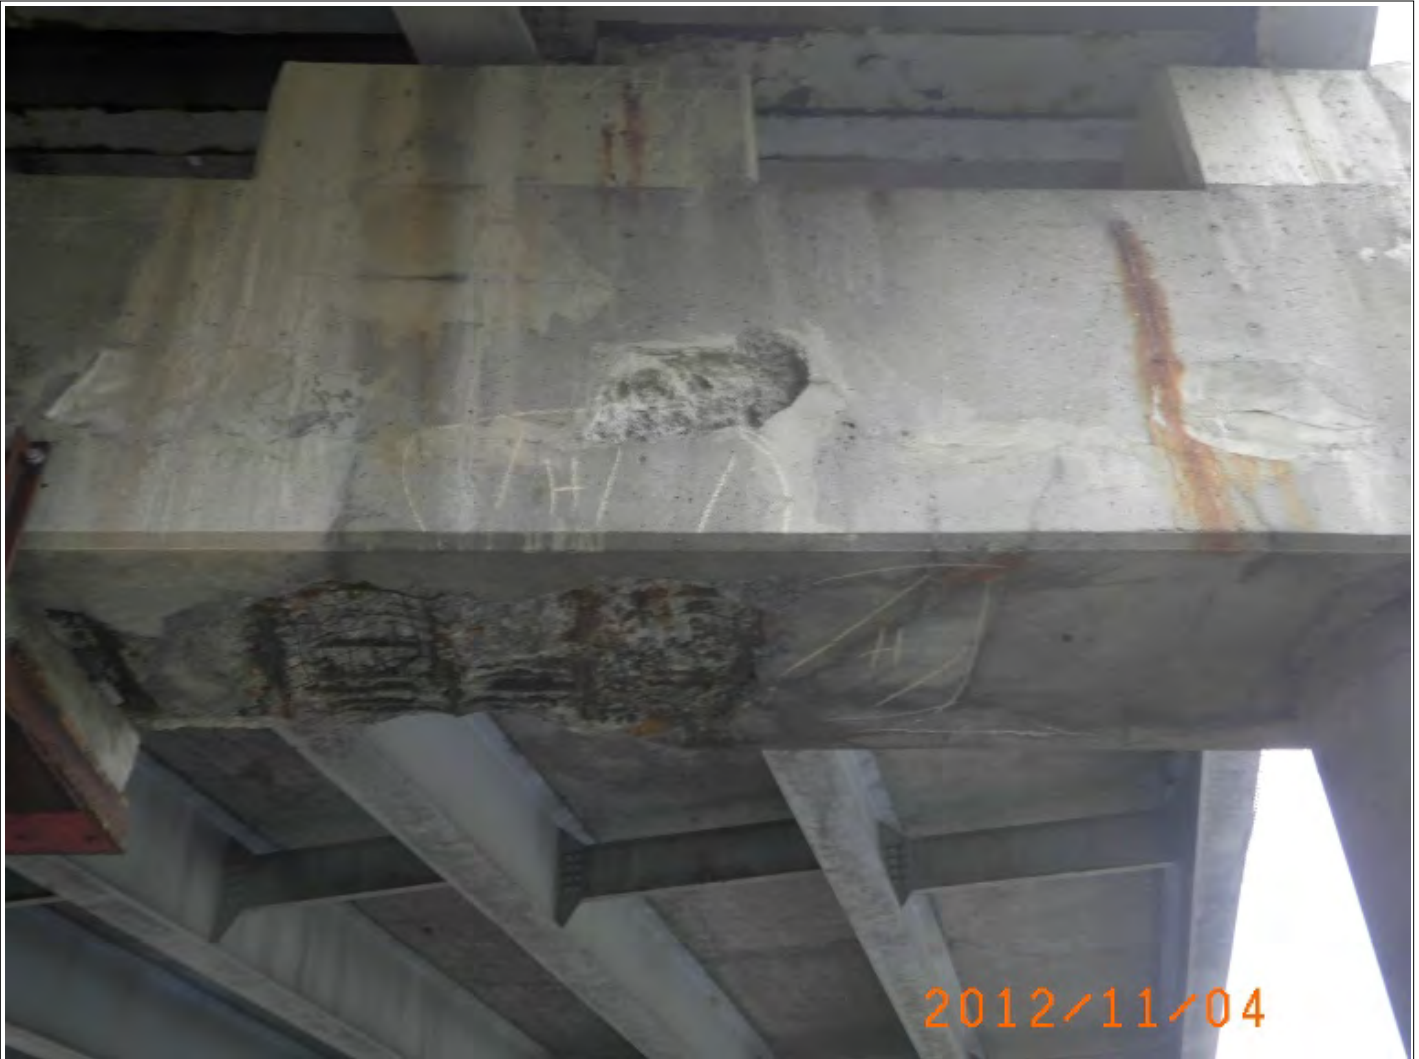
12-2867.JPG - Attached to Yellow Flag 1P120028

Spall in Begin face of cap - mid-height in Bay 2

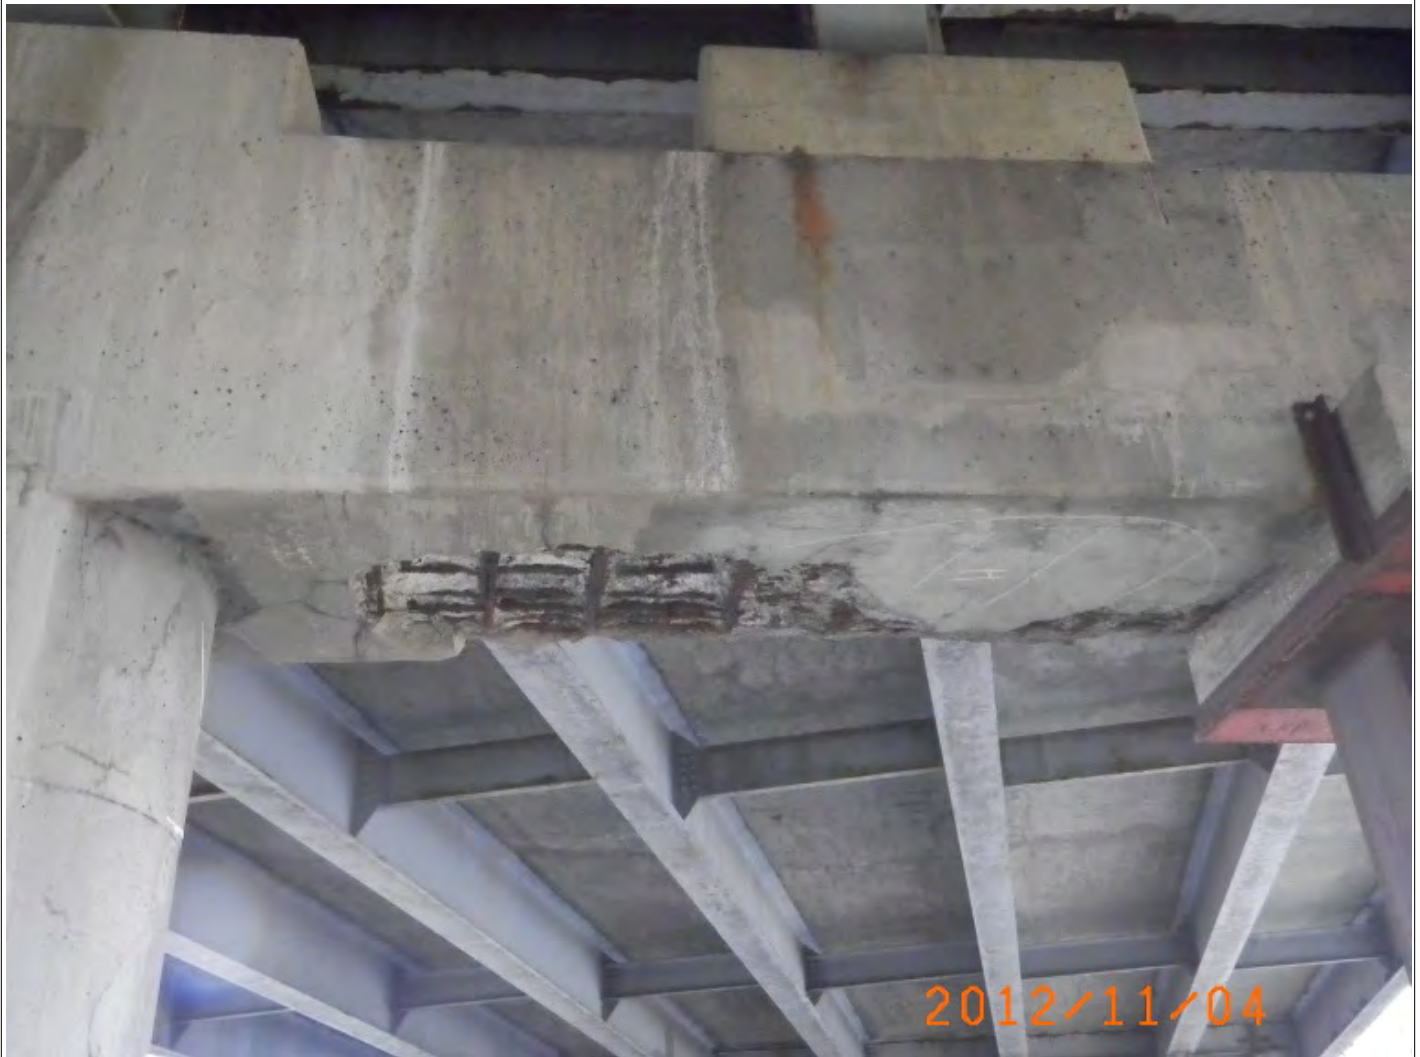
12-2868.JPG - Attached to Yellow Flag 1P120028

Underside of cap - Begin face - between Column 2 and the Bay 2 temp steel column
